Fire Damper PPM

Engineer Checksheet

Fire Damper No:	FD # 1	Site:	Sample Report
AHU No / System ID:	EAF/X/B09	System Type:	EF - Extract Fan
Location Reference:	First Floor - South (Blue) - Zone 2 - Inside STORE / AHU PLANT ROOM # AHU/1/01	Access Method inc Height:	Safe access on 8/10 tred steps
Access Panel to DW144:	Yes	Access Panel Size (mm):	200x200 AP
Description of Location & Access Notes:	Damper located high level (visible on open ceiling) - Location illustrated on drawing ref # UK1-DR-M50102-2-AS (Mechanical Services Ventilation Layout First Floor Zone 2)		
Damper Type/Series:	BSB Engineering Services Ltd FD Series Curtain Fire Damper	Vertical or Horizontal:	Vertical
Damper Mode of Operation:	BSB Engineering Services Ltd - Standard Link (LS) - Mechanical/Straight Bar Fusible Link	Damper Duct Shape & Size (mm):	300x300 sq duct
Installation Arrangement (in accordance with BESA DW/145):	*DW/145 Method 4 - Pre-formed opening in Vertical dry-lining barrier complete with factory fitted damper face plate

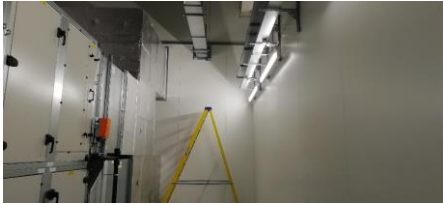
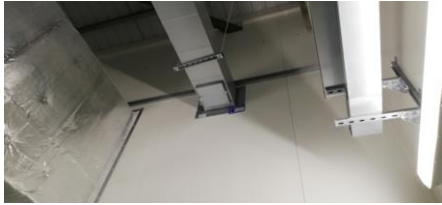
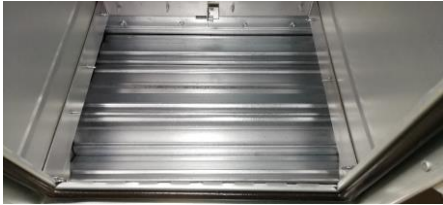
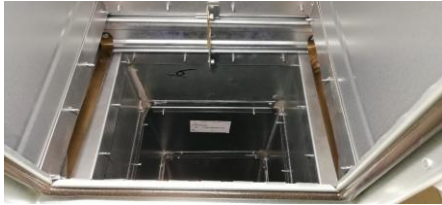
Location Reference:			Damper as found:

Drop test and Reset:			Observations:
Fire Barrier/Compartment Condition:	Satisfactory - No signs of damage or gaps	Cleanliness & Hygiene:	Clean
Action Taken:	Drop Test & Reset		
Service Result:	PASS		
Damper Defect(s):	n/a		
Remedial Notes:	n/a		
Engineer:	SN		
Date:	01 January 2021

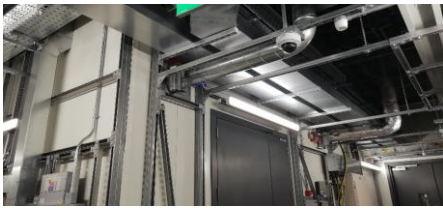
Location Reference:		Damper as found:

Fire Barrier/Compartment Condition:	Satisfactory - No signs of damage or gaps	Cleanliness & Hygiene:	Clean
Action Taken:	Drop Test & Reset		
Service Result:	PASS		
Damper Defect(s):	n/a		
Remedial Notes:	n/a		
Engineer:	SN		
Date:	01 January 2021

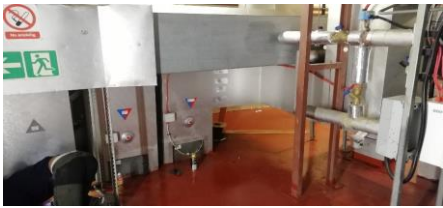
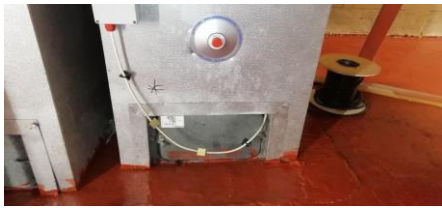
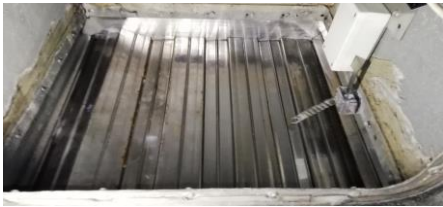
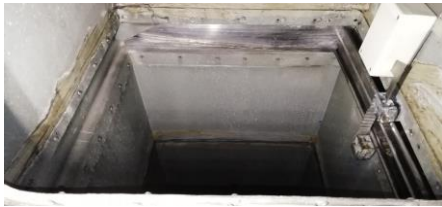
Location Reference:			Damper as found:

Fire Barrier/Compartment Condition:	Satisfactory - No signs of damage or gaps	Cleanliness & Hygiene:	Clean
Action Taken:	Cleaned, Drop Test & Reset		
Service Result:	PASS		
Damper Defect(s):	n/a		
Remedial Notes:	n/a		
Engineer:	SN		
Date:	01 January 2021

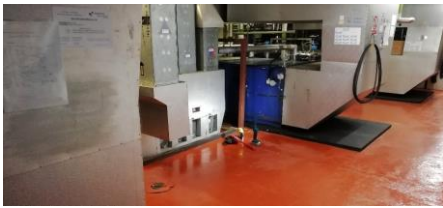
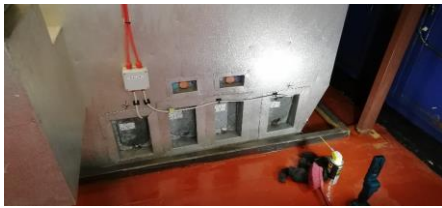
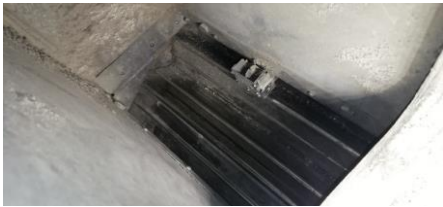
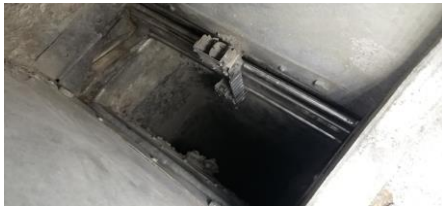
Location Reference:			Damper as found:

Fire Barrier/Compartment Condition:	Satisfactory - No signs of damage or gaps	Cleanliness & Hygiene:	Dirty
Action Taken:	Cleansed, Drop Test & Reset		
Service Result:	ADVISORY		
Damper Defect(s):	A04: Ductwork highly contaminated with dirt – Duct clean recommended		
Remedial Notes:	n/a		
Engineer:	SN		
Date:	01 January 2021
